# **Debris/Ice/TPS Assessment And Photographic Analysis For Shuttle Mission STS-42**

March 1992

DEBRIS/ICE/TPS ASSESSMENT  
AND  
PHOTOGRAPHIC ANALYSIS  
OF  
SHUTTLE MISSION STS-42

January 22, 1992

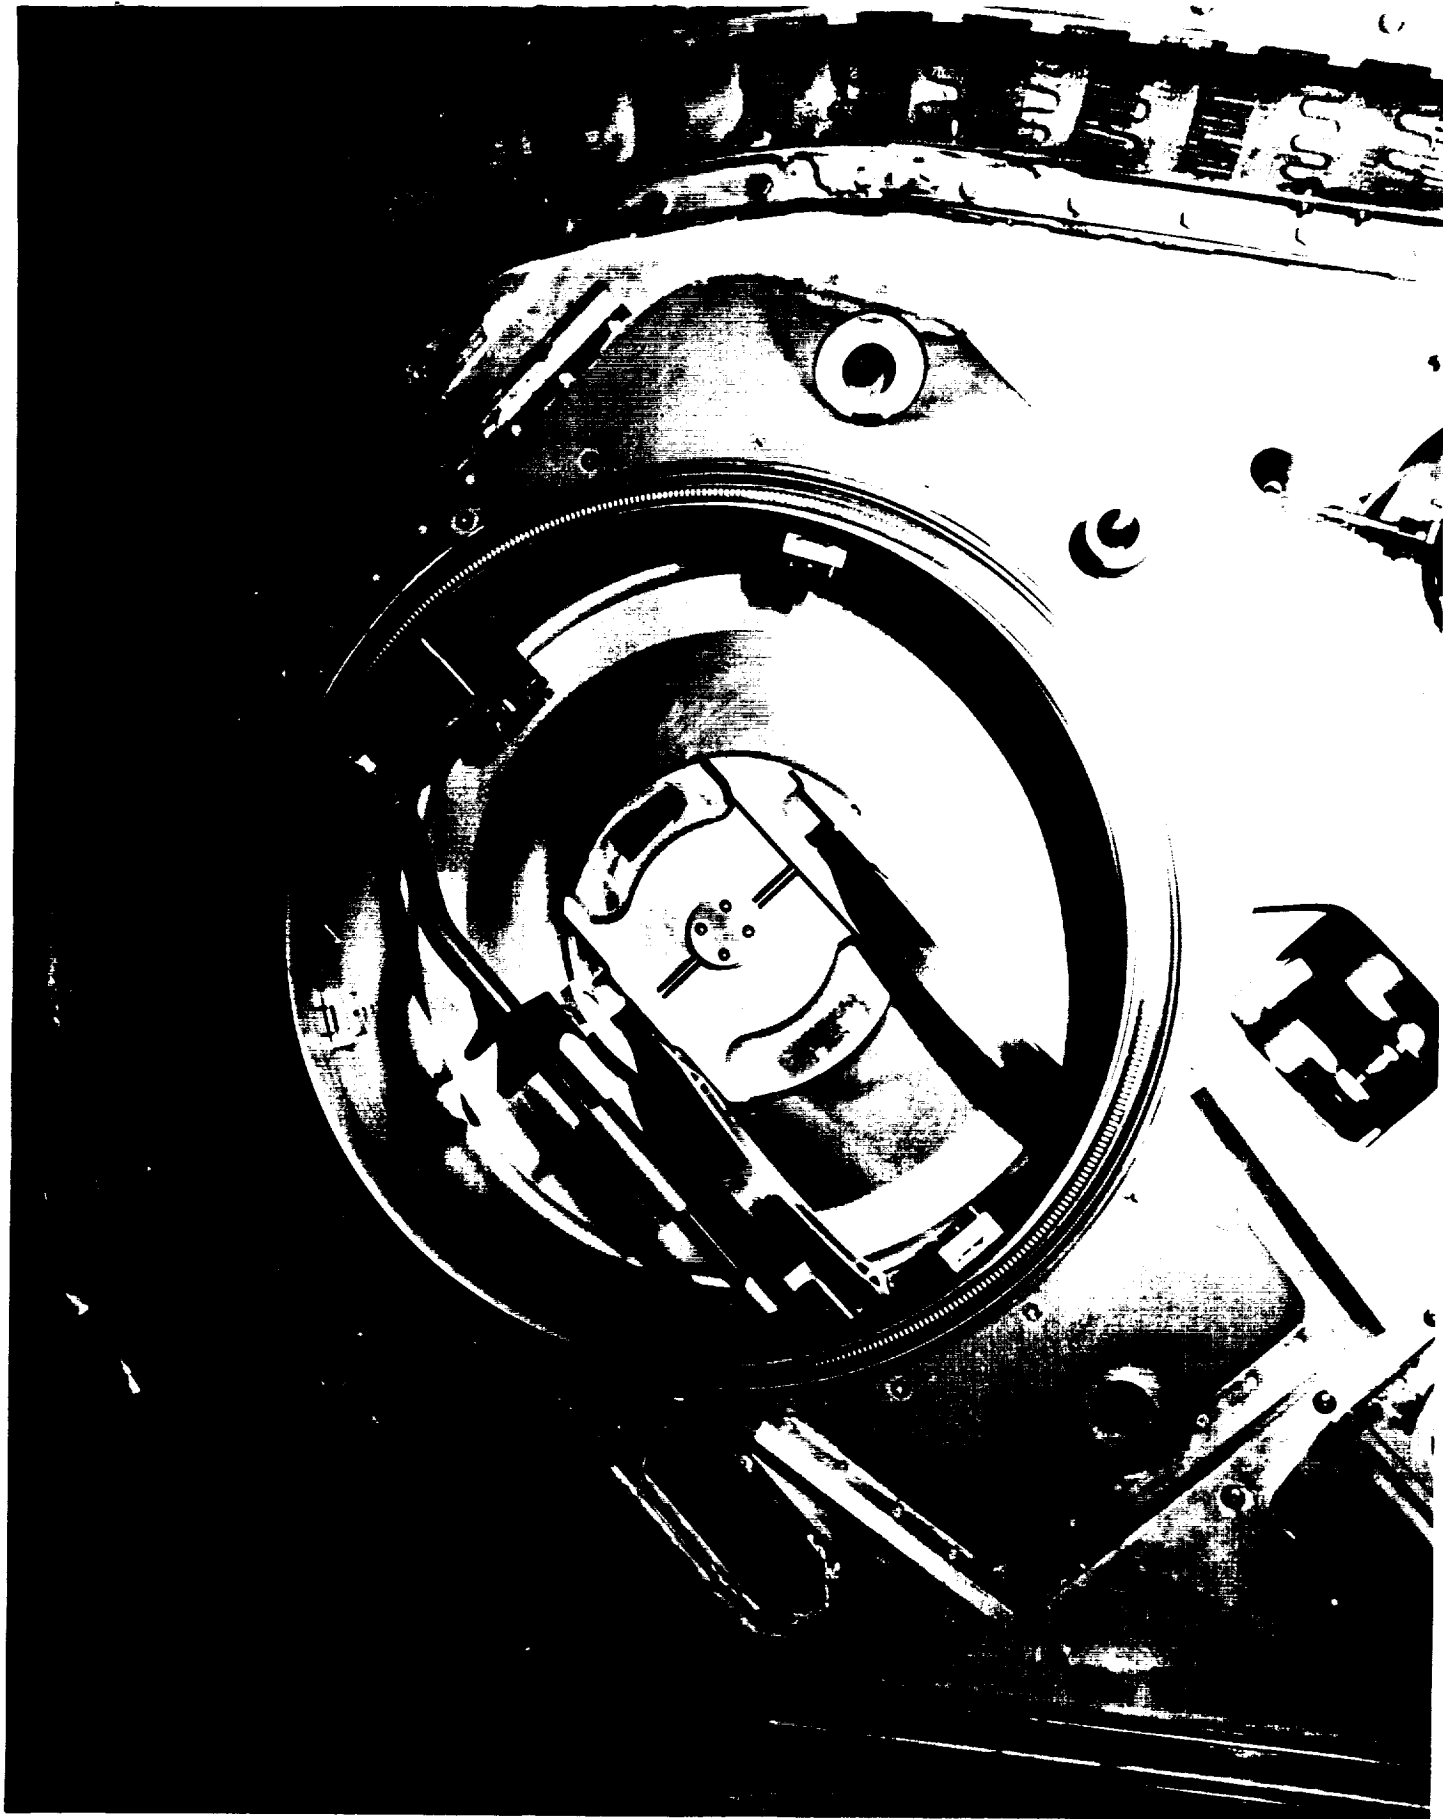
Overall view of the L02 ET/ORB umbilical. The separation ordnance device debris plunger in E0-3 was seated and appeared to have functioned properly. Wrinkling of the interface plate, particularly near the aft separation bolt hole, was attributed to shrinkage during cryogenic chilldown.
